Vessel: GO PHOENIX

Sensor: SLH ProSAS-60

SV "GO PHOENIX" MH370 SEARCH

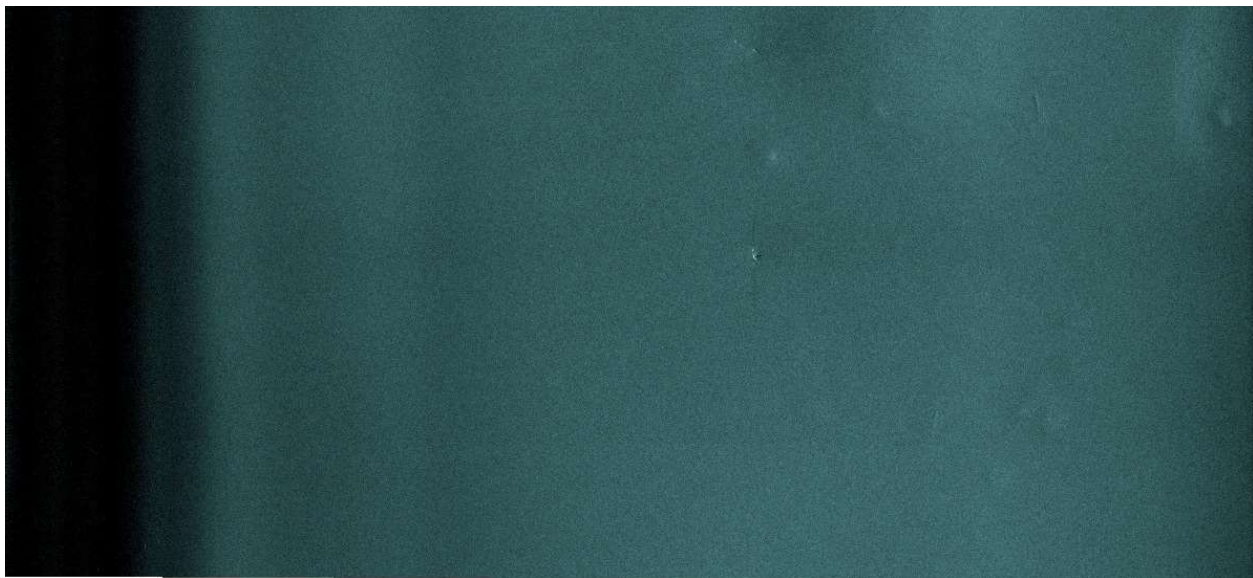
The area of interest is 570m off the starboard array of the towfish on line Z2L3N near ping# 68041. It is a very small group of targets or one irregular target. Target is 8m long and 3 meters wide with a minimal shadow indicating about little vertical height off bottom.

Contact was detected on Starboard array. Located 570 m from sensor. Ping # 68041.

There are no plans to investigate this contact further.

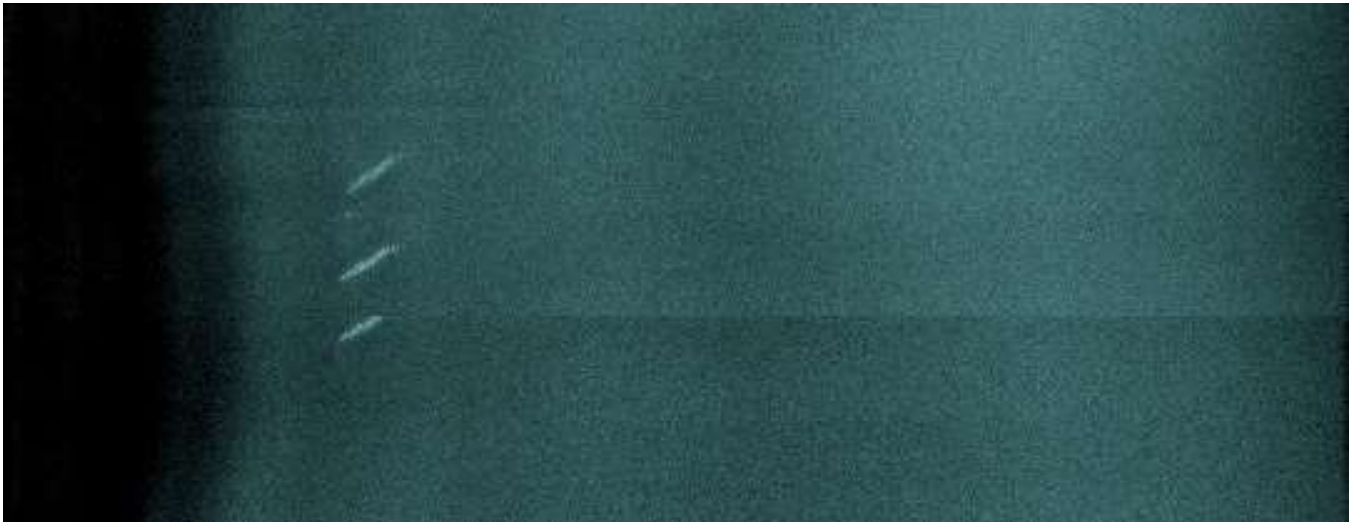
Contact is 250m from the starboard array near ping # 138969 on line Z2L1S. The target is a linear object. It measures approximately 50m long and 5m wide. There is no shadow and appears to be secondary ghost images?

Contact has a strong return 250m from the array with no visible shadow. What appears to be individual targets could be ghosting of the original contact?

There are no plans to investigate this contact further.

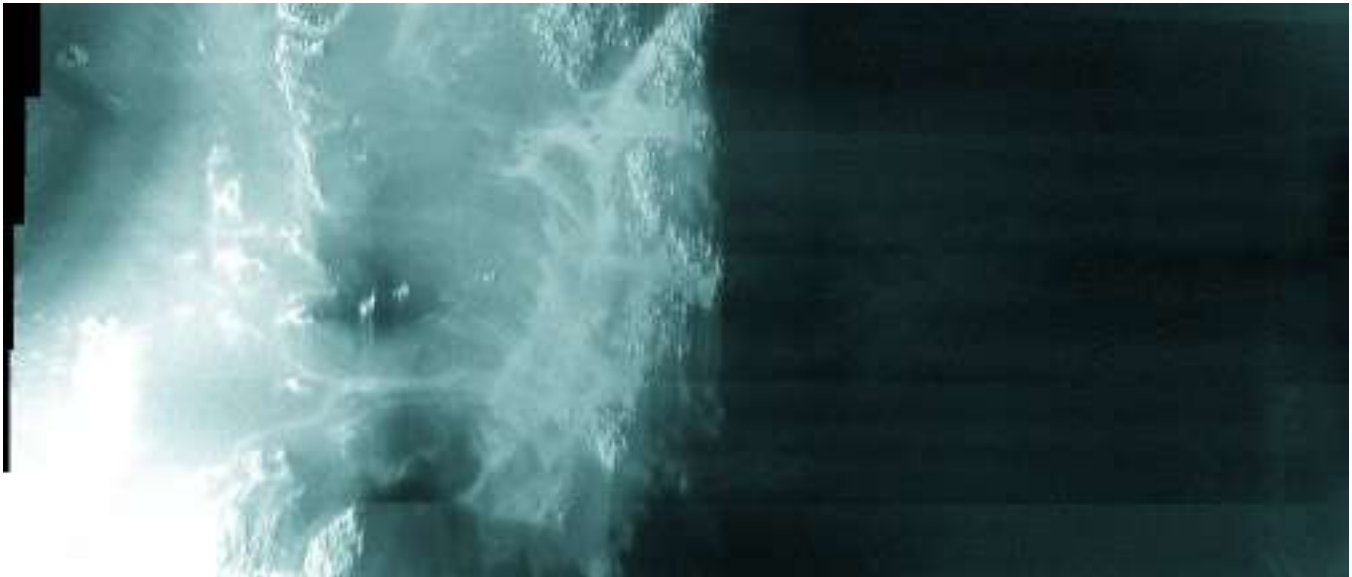
At Ping 570119, 294.17m on starboard side. This area is near the top of a uphill slope, possible in a depression of the top of the ridge. Slant range angles and distances can be affected.

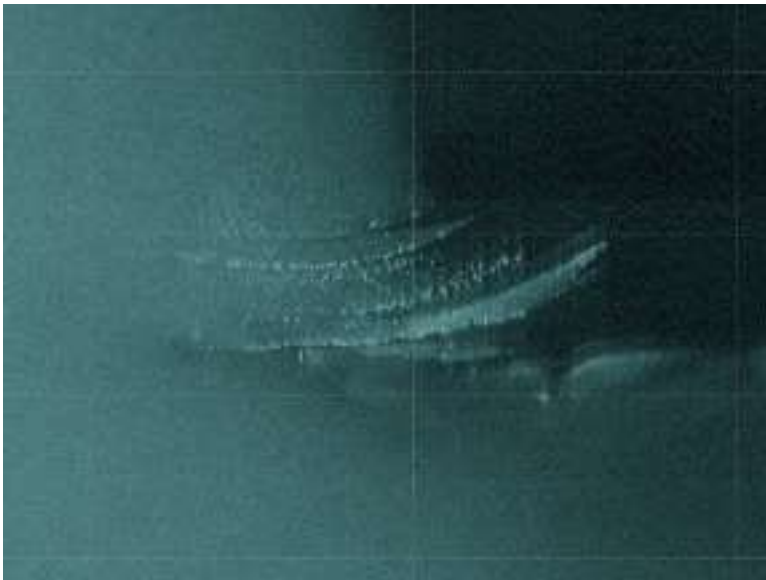
The target area is 145m long across track and 55m along track. There is no measureable relief partly due to the shadow of the associated sediment mound.

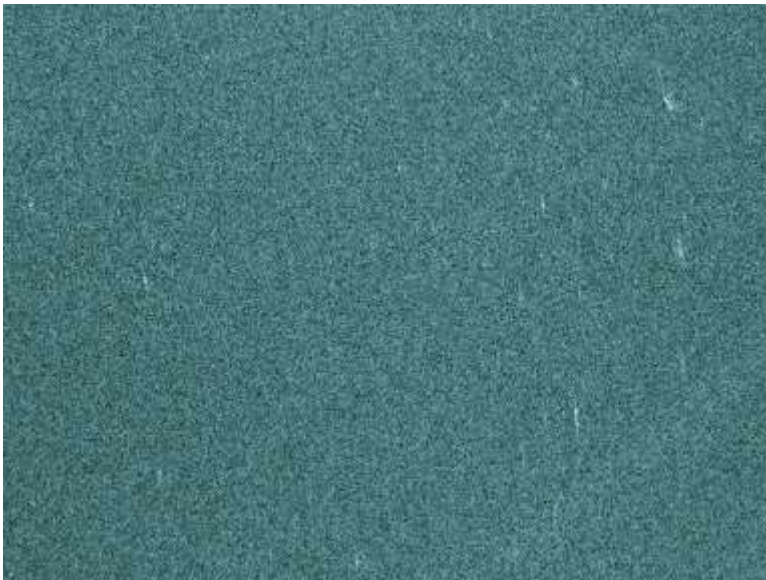
Cluster of smaller targets, each no larger than 1 m long.

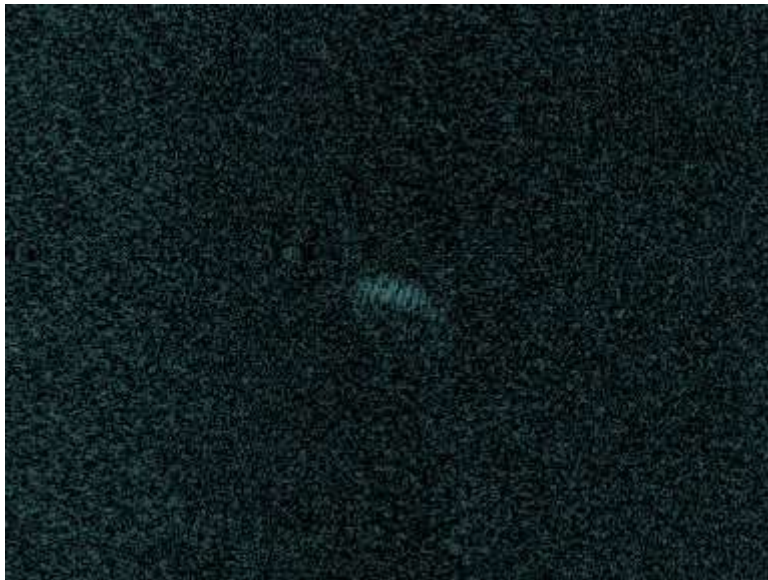
Target is approximately 6 m x 2 m.

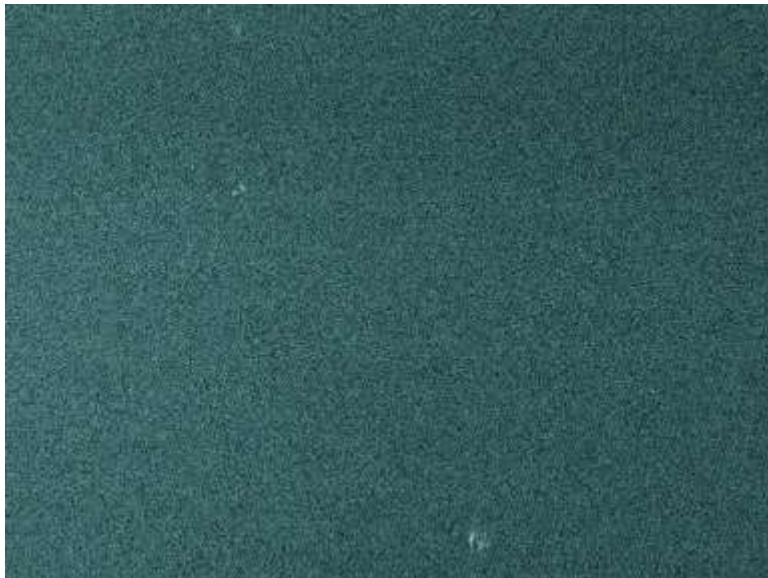
The largest target is approximately 3.5 m x 3.0 m.

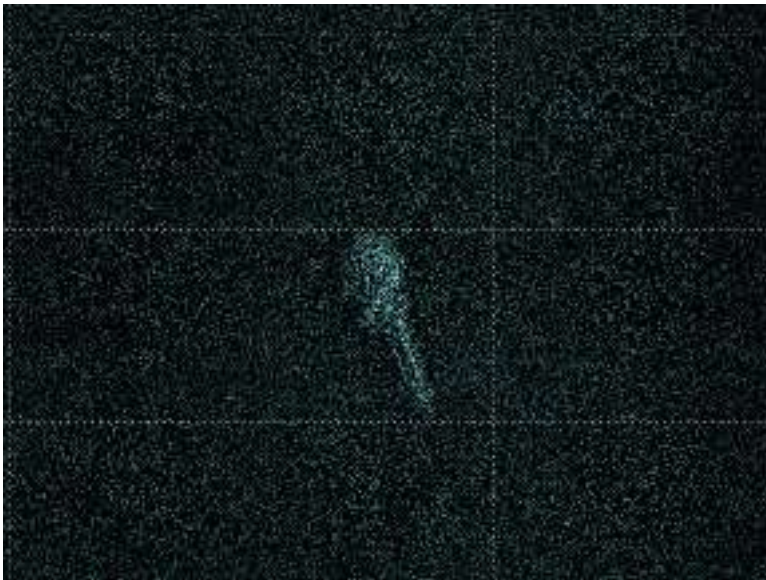
Isolated object approximately 19 meters by 7 meters with linear features.

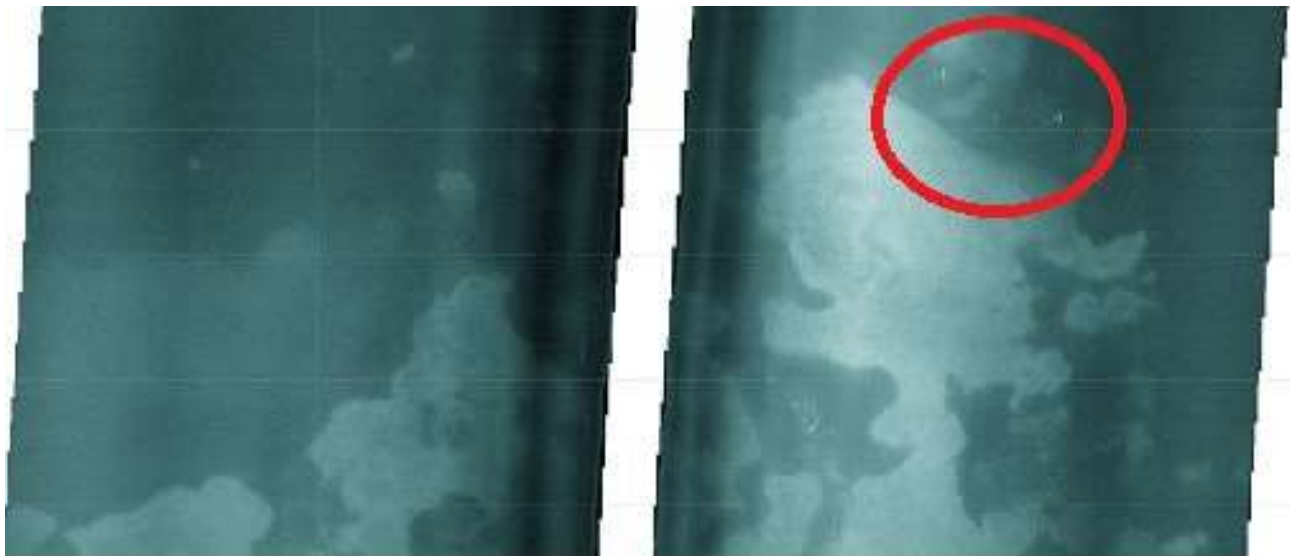
12 meter by 2.5 meter bright angular contact in a cluster of 5 smaller, bright contacts. Likely geologic in origin.

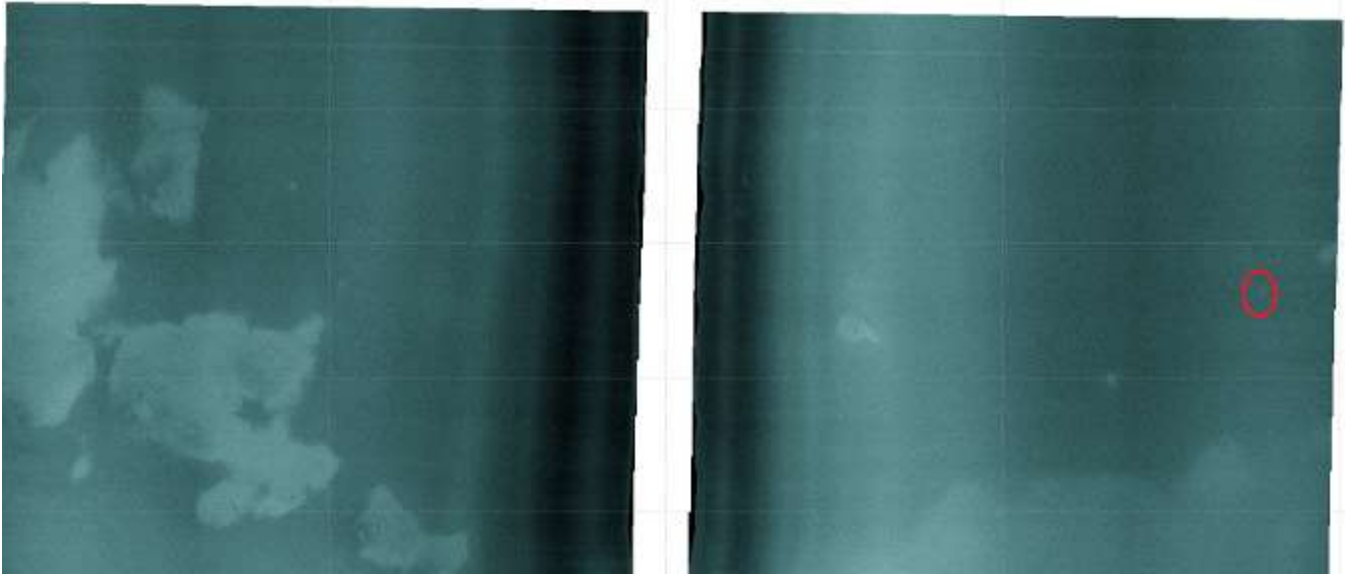
2 bright returns, both approximately 2.5 meters by 1 meter in close proximity to each other (approximately 2 meters). QINSY FILE:

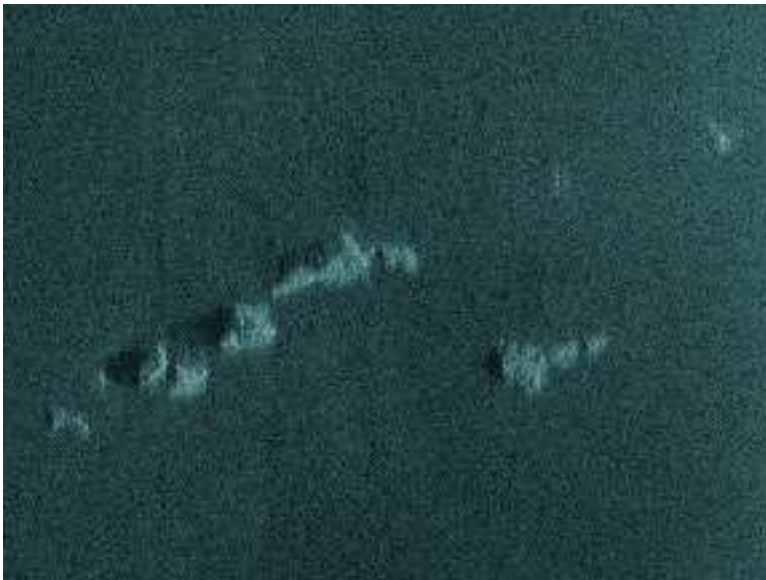
Six large contacts, 5 m to 16 m long and 3 m to 8 m wide. Maximum height is 3.9 m. Four smaller contacts less than 2 m long by 2 m wide. Negligible height.
